# Re-Build of Chlorate Unloading Tank at the Verso Quinnesec Mill & the Installation of an External Heater

PAPTAC Fall Meeting

November 6-8, 2019

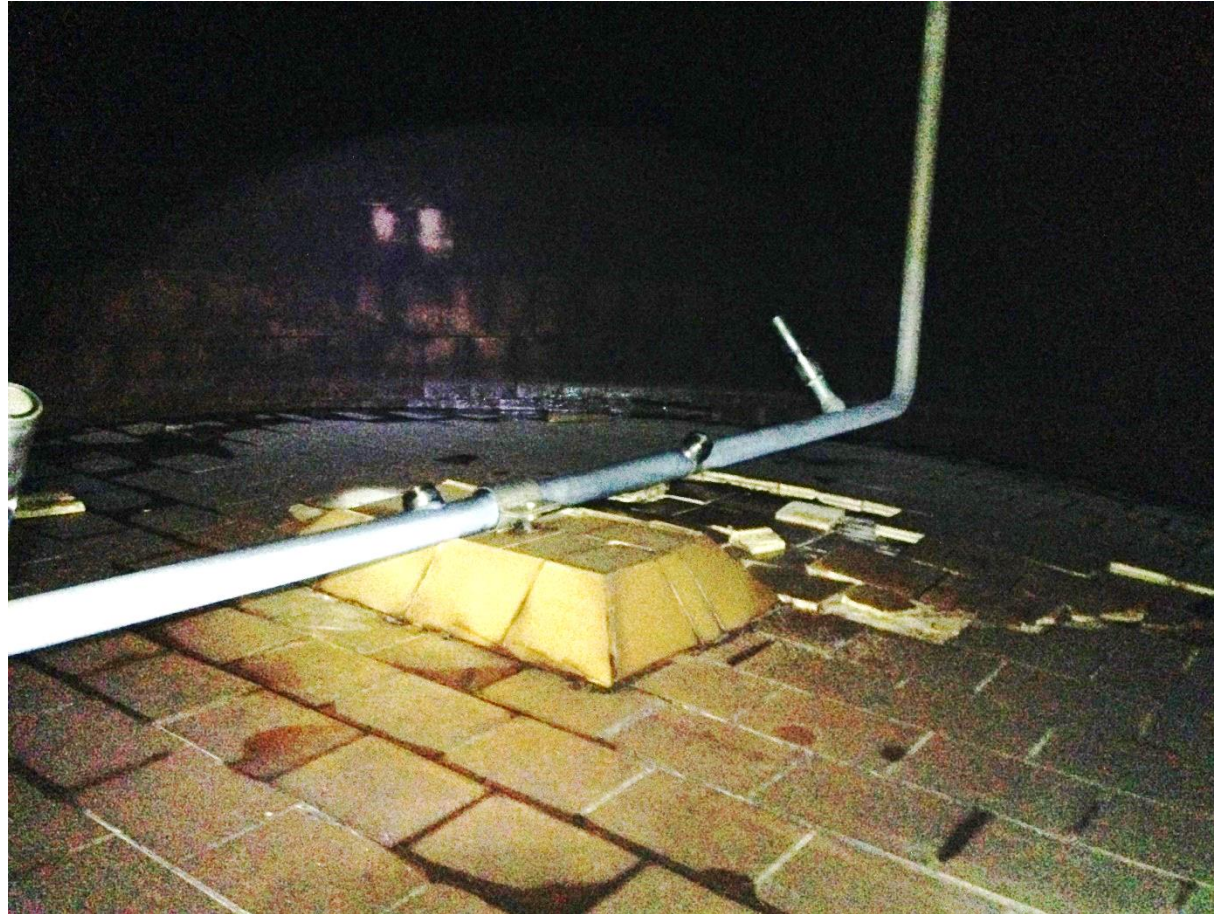
# Damaged Tile and Missing Nozzles

- The tank was significantly corroded from the inside & outside and had significant tile damage on the inside.
- The tank had many repairs to tile in the past and was an expensive “every outage” maintenance item. Steel had also been replaced on the tank in the past due to corrosion.
- Leaks in early 2018 resulted in the tank being taken out of service. Upon internal inspection structural integrity was questionable without significant rebuild.
- Internal direct steam heating contributed to tile damage and accelerated corrosion.

Common to see this every time the tank was opened for a major outage

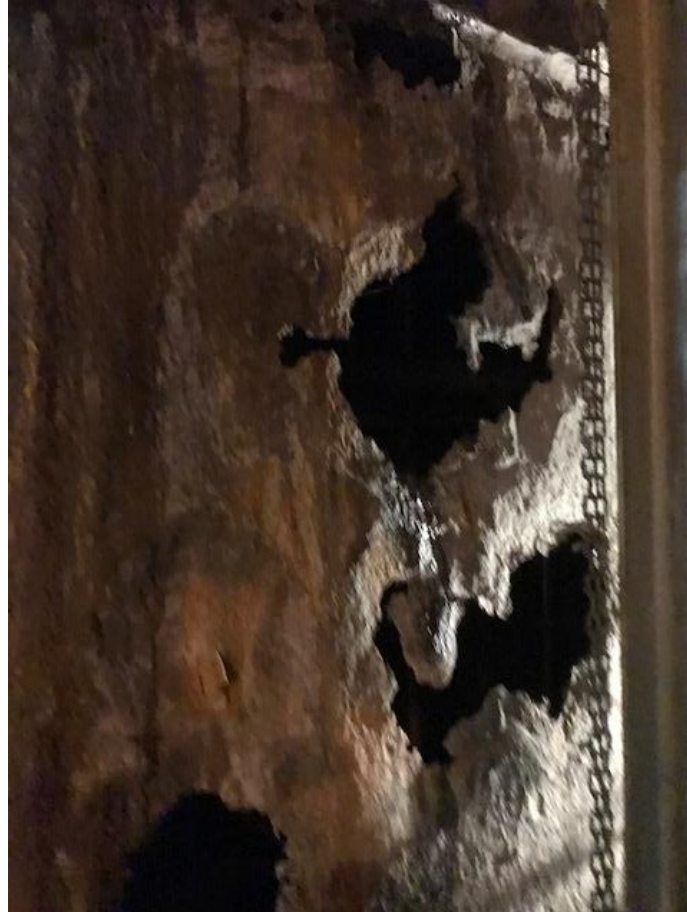
# An Area of the Tank Sidewall

**After tile and group was removed it was quite obvious the tank was in extremely bad shape**

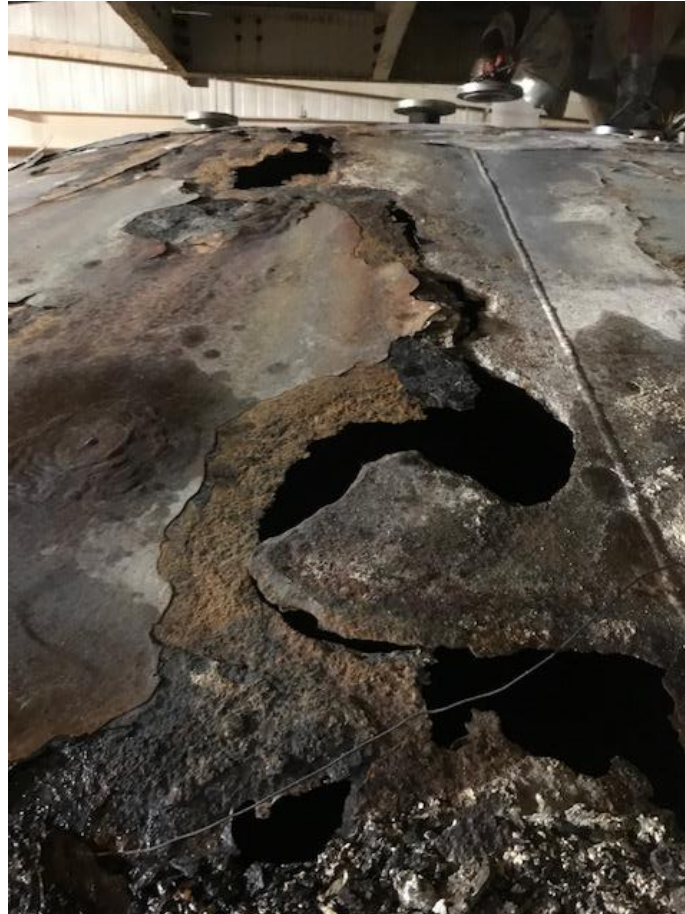
# Roof of Tank

**This is why we don't walk on tank roofs we don't know the condition of!**

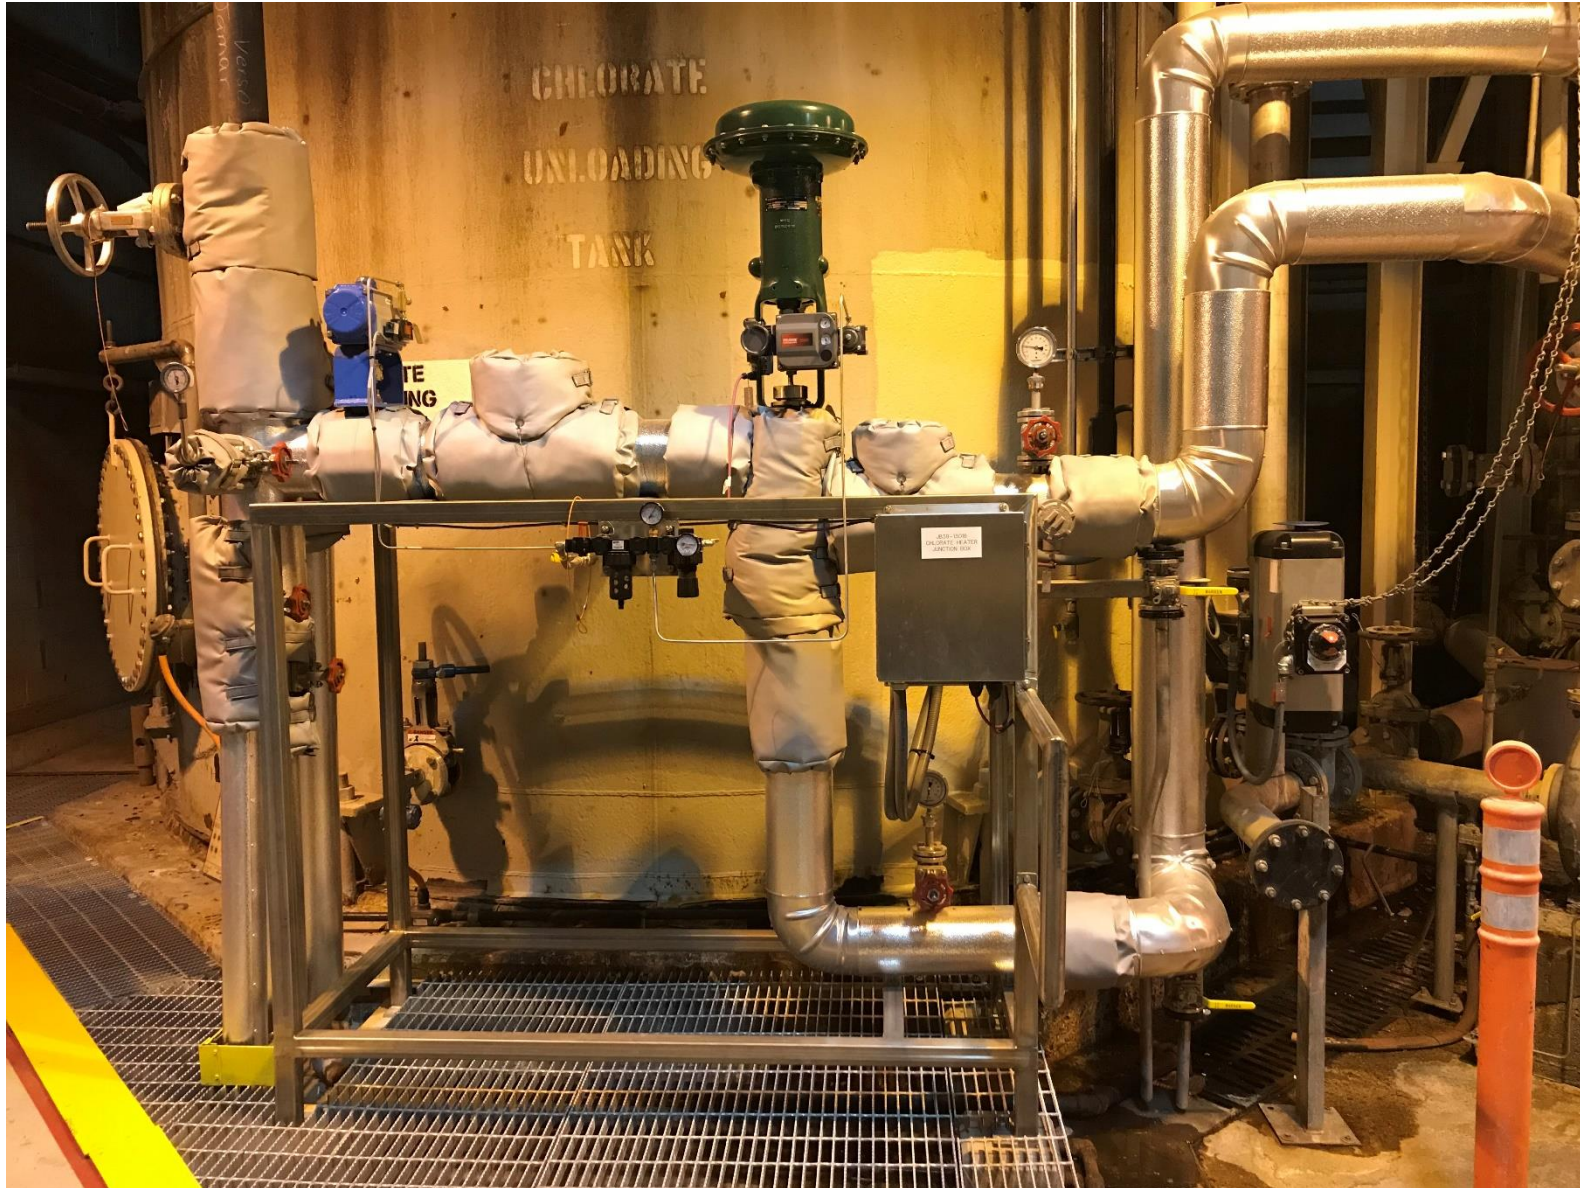
# Installed Heater

- Model K612
- Operates similarly to a steam control valve
- Interlocked to prevent exceeding FRP temperature maximum
- Comes with a flow switch to prevent adding steam with no flow of fluid to be heated
- Recommended to have an automated flushing sequence
- Has been running since early July with no issues
- 2205 Alloy on wetted parts
